PROBLEM SOLVED™ PAPER

SOLUTION: Martin® QC1 HD with Metal Tipped Blade

INDUSTRY: Asphalt Production

LOCATION: Vitali Olbia Asphalt Plant; Olbia, Sardinia, Italy

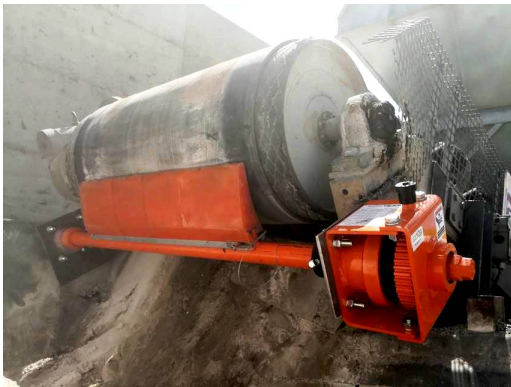
The QC1 HD Cleaner with Metal Tipped Blade is designed to handle highly abrasive materials.

After a thorough review of the conveying system, the Mr. Blade technician recommended two Martin QC1 HD Belt Cleaners with Metal Tipped Blades to handle the highly abrasive materials. The QC1 is a primary blade and spring tensioner system designed to keep a tight seal across the blade profile, with minimal wear on the belt or splice. For the first conveyor, a standard orange blade was used for its ability to handle abrasive conditions. For the second belt, which feeds the oven, a green high-temperature blade was installed, able to withstand continuous temperatures of -40 to 150°C (-40 to 300°F) and intermittent exposure to temperatures as high as 177°C (350°F).

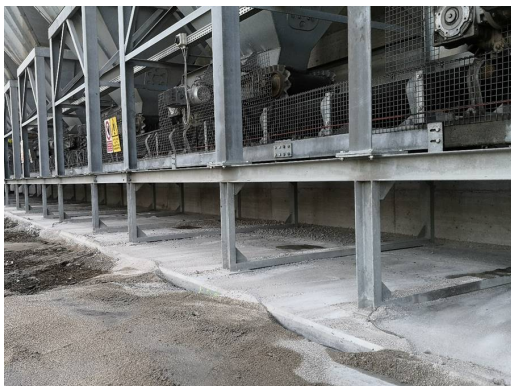
Daily cleanup of spillage has now been reduced to removal as needed just once every 6-7 weeks.

Upon completing the installations, the improvement was readily apparent, and the plant manager noted the absence of fugitive material that accumulated so quickly before. Instead of daily cleanup, maintenance workers now check for spillage and remove as needed just once every 6-7 weeks. "We subscribed to the Mr. Blade program at a number of our production sites in 2019, and we quickly saw the benefits in reduced spillage and increased system uptime," said Luigi Pinna. "We anticipate that the program will continue to help us improve productivity, reduce carryback and minimize spillage, and we hope to extend the program to more of our plants in the coming months."
