PROBLEM SOLVED™ PAPER

SOLUTION: Martin® Transfer Point Products

INDUSTRY: Pulp and Paper

LOCATION: West Coast Paper Mills Ltd / Dandeli, Karnataka, India

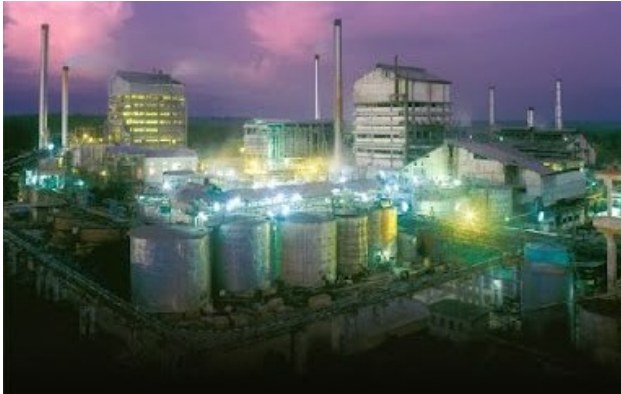
The West Coast Paper Mills facility in Dandeli handles approximately 320,000 tons of lime per year.

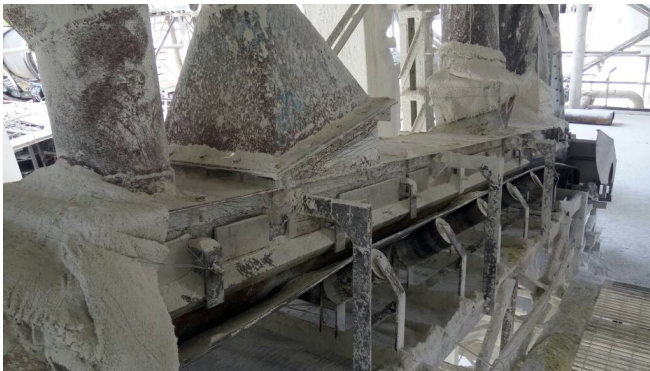
Material loss, potential health & safety hazards and excessive cleanup time were all motivating factors.

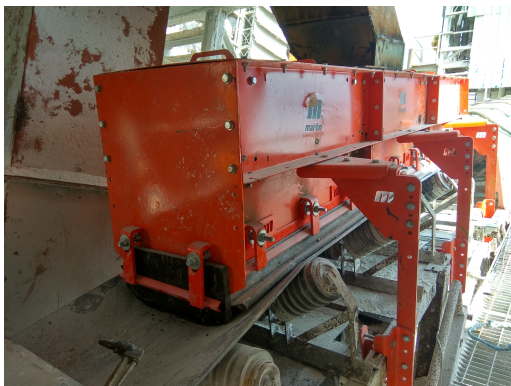
The modular chute box, sealing components & dust bags successfully contain the dry, powdered load.

Martin service technicians visited the site and recommended a combination of passive dust management and fugitive material controls to alleviate the problems. With the Martin Service Technician supervising, customer personnel assembled a Martin® Modular Chute Box, with Martin® External Wear Liner along the length of the loading and settling zones. They outfitted the rebuilt chute with Martin® BOCO Skirting to better contain the load and Martin® Apron Seal to help prevent fines from escaping. Dust curtains were added to control the air flow and improve settling, with a Martin® Dust Bag to use the positive air pressure from the chute as the driving force for filtration and reduce the local overpressure around the loading point.
