PROBLEM SOLVED™ PAPER

SOLUTION: System Analysis by Martin Engineering and Martin®
Transfer Point Products
INDUSTRY: Food Processing

LOCATION: U.S. Sugar Corporation, Clewiston, Florida

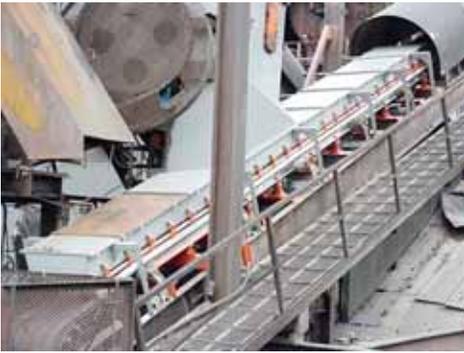
This transfer point at the sugar refinery features new belt support cradles and a new edge sealing system.

Martin Engineering provided a detailed engineering study that listed a number of recommendations. They included: moving the head pulley of one conveyor and the tail pulley of a second conveyor, lowering the overall height of a third conveyor, changing three conveyors to a picking-idler style to improve cargo capacity, installation of training devices to improve belt tracking and upgrading the belt cleaners on all conveyors to improve cleaning performance.
